**Flood Control Project Maintenance  
Levee Inspections**

**Maintenance Issue Types Only, Levee Inspection Report By Mile - Fall 2018**

**Reclamation District No. 0544 Upper Roberts Island**

Waterway	Bank	Unit Miles	Inspection Start/End	Inspector
Unit No. 01 San Joaquin River	Left	6.05	09/13/2018 09/13/2018	Richard Willoughby

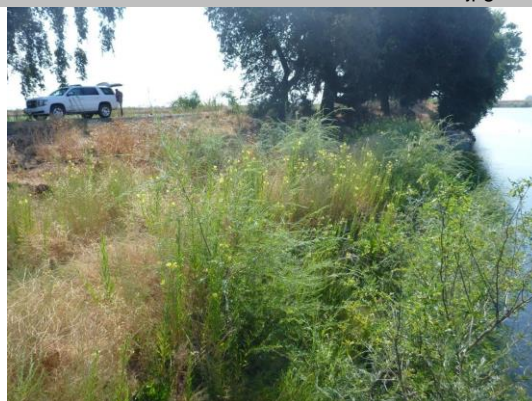
Photo 4 of 4 : LEVAL\_FA\_2018\_550\_4575.jpg

Item	2017 Storm Damage		37.820400°	37.820500°								
			-121.345800°	-121.345900°								
DWR ID	DWR_RD0544_02_f_2017_88											
Comment Code												
Inspector Comment												
Levee Evaluation Comments Description: Slope protection repairs are needed along the waterside slope due to erosion and riprap displacement from high water. Based upon levee inspections, it was determined the waterside levee slope is eroding, deteriorating, and degrading. The eroded levee sections need to be restored back to design standards to prevent further deterioration and damage. Site ID No: 550 Site Designation: LMA-456 Repair Type: Erosion Rating: Area of Concern Field Date: 8/18/2017 Notes:

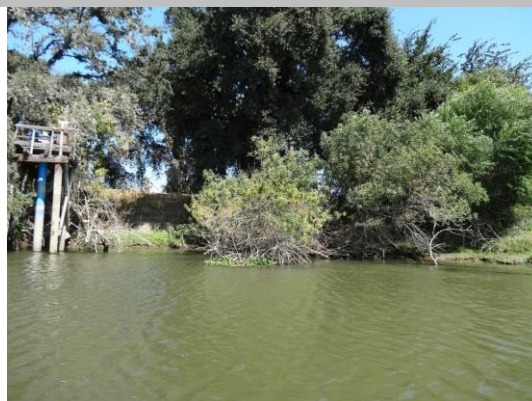
Photo 1 of 3 : FA\_2018\_RD0544\_109\_11\_20180906\_00012.jpg

LM Start	2.31	Rating **	M	Issue No.	11
LM End	2.31	Issue Type +	Ma	Location *	WS
Category	Supplemental			GPS Latitude/Longitude	
				Start	End
Item	DWR Erosion Survey			37.821763 °	37.821763 °
				-121.347275 °	-121.347275 °
DWR ID	RD0544U02RM33.21				
Comment Code					
Inspector Comment					
09/13/2017: No significant change observed.					
07/25/2016: No significant change observed.					
06/25/2015: No significant change observed.					
07/02/2014: No significant change observed.					
08/20/2013: No significant change observed.					
08/07/2012: The site was first reported in 2012 spring levee inspection report. The data were estimated as the site is underneath a irrigation pump station and inaccessible by boat or land survey. It's possible the pump station played a role in the erosion. [2017 Site ID:RD0544U02RM33.21]

Front view of the erosion site. View is partially blocked by the pump structure and vegetation at the site.

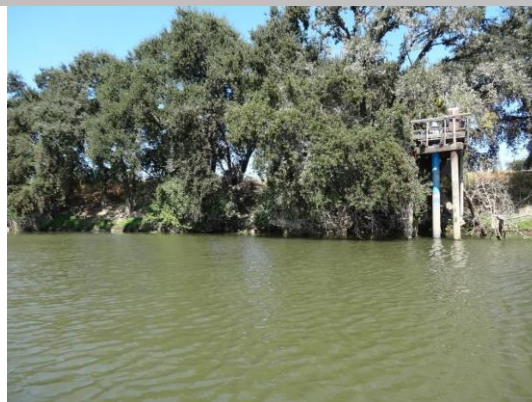
Photo 2 of 3 : FA\_2018\_RD0544\_109\_11\_20180906\_00013.jpg

Front view of the site.

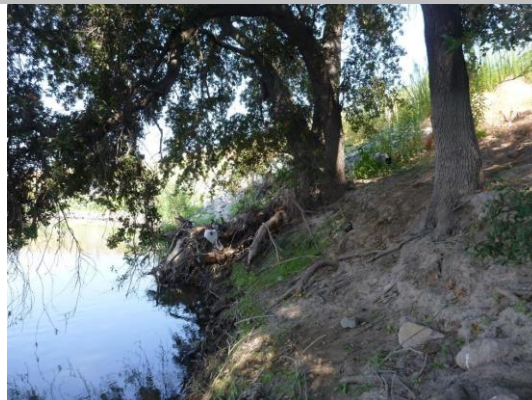
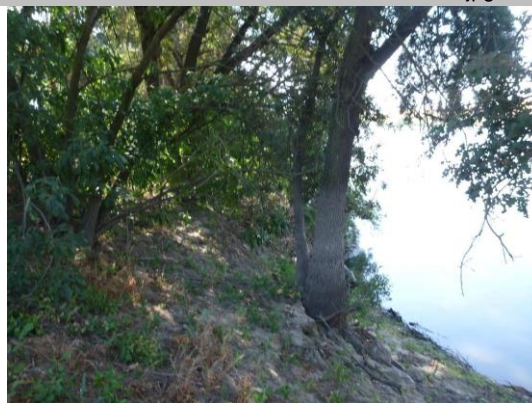
LM Start	2.32	Rating **	A/W	Issue No.	89 (cont)	
LM End	2.33	Issue Type +	Ma	Location *		
Category	Supplemental			GPS Latitude/Longitude		
				Start	End	
Item	2017 Storm Damage			37.821800 °	37.821900 °	
				-121.347500 °	-121.347600 °	
DWR ID	DWR_RD0544_02_f_2017_89					
Comment Code						
Inspector Comment						
Levee Evaluation Comments						
Description:Slope protection repairs are needed along the waterside slope due to erosion and riprap displacement from high water. Based upon levee inspections, it was determined the waterside levee slope is eroding, deteriorating, and degrading. The eroded levee sections need to be restored back to design standards to prevent further deterioration and damage.						
Site ID No:549						
Site Designation:LMA-455						
Repair Type: Erosion						
Rating:Area of Concern						
Field Date:8/18/2017						
Notes:

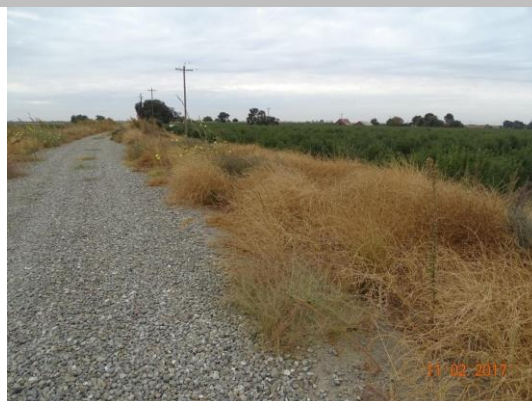
Photo 1 of 1 : FA\_2018\_RD0544\_109\_73\_20180906\_00056.jpg

LM Start	2.41	Rating **	U	Issue No.	73	
LM End	2.59	Issue Type +	Ma	Location *	LS	
Category	Earthen Levee			GPS Latitude/Longitude		
				Start		End
Item	Vegetation			37.821423 °		37.819153 °
				-121.348849 °		-121.350231 °
DWR ID	DWR_RD0544_02_f_2017_73					
Comment Code						
V2 : Remove the wild growth other than native grasses from the levee slopes.						
Inspector Comment

Looking southwest at the landside slope.

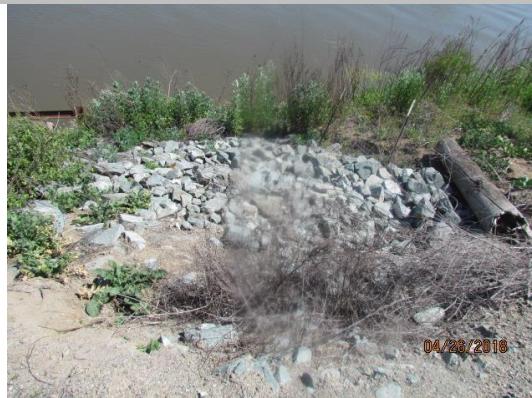
Photo 2 of 5 : FA\_2018\_RD0544\_109\_69\_20180906\_00048.jpg

LM Start	2.61	Rating **	U	Issue No.	69 (cont)	
LM End	2.61	Issue Type +	Ma	Location *	WS	
Category	Earthen Levee			GPS Latitude/Longitude		
				Start		End
Item	Erosion / Bank Caving			37.818806 °		37.818806 °
				-121.350437 °		-121.350437 °
DWR ID	DWR_RD0544_02_f __ 2016_69					
Comment Code						
E2 : Schedule repair of erosion site prior to the next inspection.						
Inspector Comment						
Erosion greater than 1' deep and greater than 3' wide. Owner backfilled erosion with rock 3/4 filled. Still need to backfill the remaining erosion.

Looking east at erosion on waterward slope. (Spring 2018)

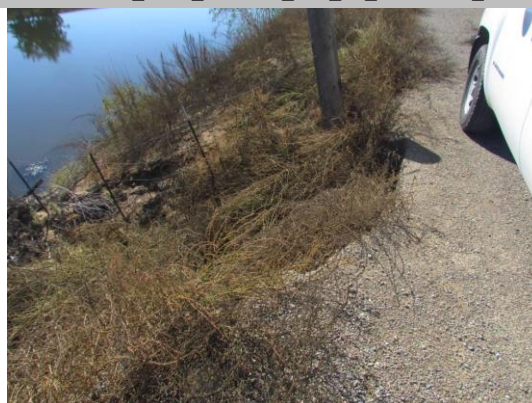
Photo 3 of 5 : FA\_2018\_RD0544\_109\_69\_20180906\_00049.jpg

Looking south at erosion on waterward shoulder and slope.

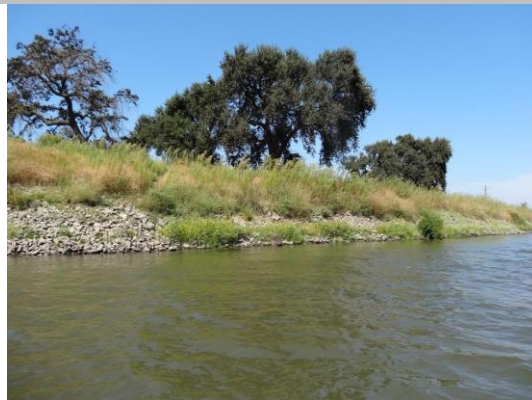
Photo 1 of 2 : FA\_2018\_RD0544\_109\_7\_20180906\_00004.jpg

LM Start	2.68	Rating **	M	Issue No.	7
LM End	2.70	Issue Type +	Ma	Location *	WS
Category	Supplemental			GPS Latitude/Longitude	
				Start	End
Item	DWR Erosion Survey			37.817905 °	37.817905 °
				-121.351102 °	-121.351102 °
DWR ID	RD0544U02RM32.91				
Comment Code					
Inspector Comment					
09/13/2017: No significant change observed.					
07/25/2016: No significant change observed.					
06/25/2015: No significant change observed.					
07/02/2014: No significant change observed.					
10/11/2013: No significant change observed.					
08/07/2012: Series of pocket erosion were discovered at the levee toe during the boat survey. The area is covered with vegetation and riprap, but the rip rap has been washed away. [2017 Site ID:RD0544U02RM32.91]

Front view of the pocket erosion. Note vegetation and riprap at the site.

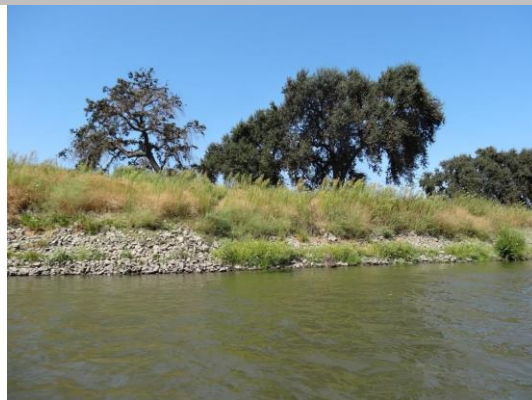
Photo 2 of 2 : FA\_2018\_RD0544\_109\_7\_20180906\_00005.jpg

Front view of the pocket erosion.

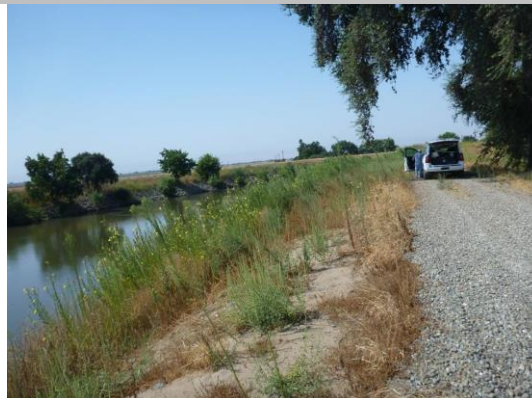
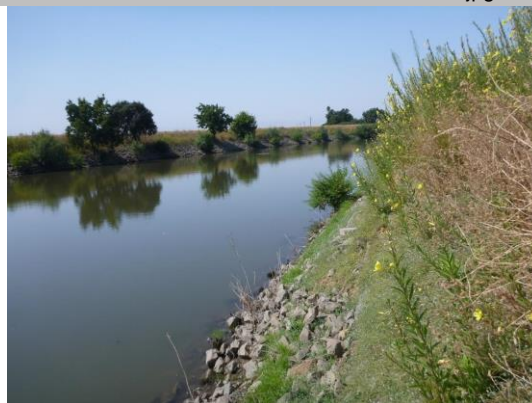
LM Start	2.68	Rating **	A/W	Issue No.	90
LM End	2.71	Issue Type +	Ma	Location *	
Category	Supplemental			GPS Latitude/Longitude	
				Start	End
Item	2017 Storm Damage			37.818000 °	37.817800 °
				-121.351200 °	-121.351500 °
DWR ID	DWR_RD0544_02_f_2017_90				
Comment Code					
Inspector Comment					
Levee Evaluation Comments					
Description:Slope protection repairs are needed along the waterside slope due to erosion and riprap displacement from high water. Based upon levee inspections, it was determined the waterside levee slope is eroding, deteriorating, and degrading. The eroded levee sections need to be restored back to design standards to prevent further deterioration and damage.					
Site ID No:548					
Site Designation:LMA-454					
Repair Type: Erosion					
Rating:Area of Concern					
Field Date:8/18/2017					
Notes:

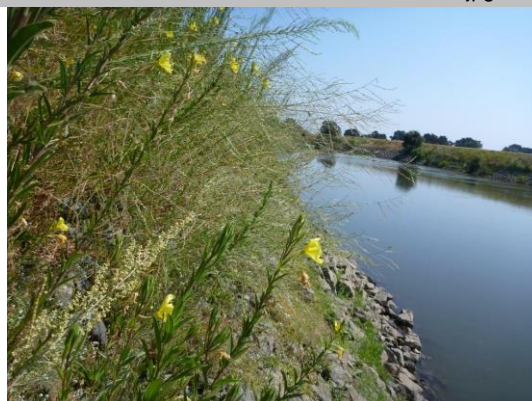
Photo 3 of 3 : LEVAL\_FA\_2018\_548\_4669.jpg

LM Start	2.68	Rating **	A/W	Issue No.	90 (cont)
LM End	2.71	Issue Type +	Ma	Location *	
Category	Supplemental			GPS Latitude/Longitude	
				Start	End
Item	2017 Storm Damage			37.818000 °	37.817800 °
				-121.351200 °	-121.351500 °
DWR ID	DWR_RD0544_02_f _ 2017_90				
Comment Code					
Inspector Comment					
Levee Evaluation Comments					
Description:Slope protection repairs are needed along the waterside slope due to erosion and riprap displacement from high water. Based upon levee inspections, it was determined the waterside levee slope is eroding, deteriorating, and degrading. The eroded levee sections need to be restored back to design standards to prevent further deterioration and damage.					
Site ID No:548					
Site Designation:LMA-454					
Repair Type: Erosion					
Rating:Area of Concern					
Field Date:8/18/2017					
Notes:

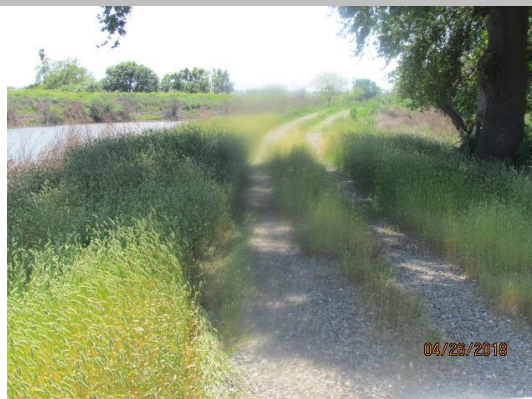
Photo 1 of 3 : FA\_2018\_RD0544\_109\_52\_20180906\_00035.jpg

LM Start	2.69	Rating **	U	Issue No.	52
LM End	3.11	Issue Type +	Ma	Location *	CR
Category	Earthen Levee			GPS Latitude/Longitude	
				Start	End
Item	Vegetation			37.817928°	37.817698°
				-121.351355°	-121.358582°
DWR ID	DWR_RD0544_02_f_2014_52				
Comment Code					
V9 : Keep the crown roadway free of vegetation.					
Inspector Comment

Looking south at veg on levee crown. (Spring 2018)

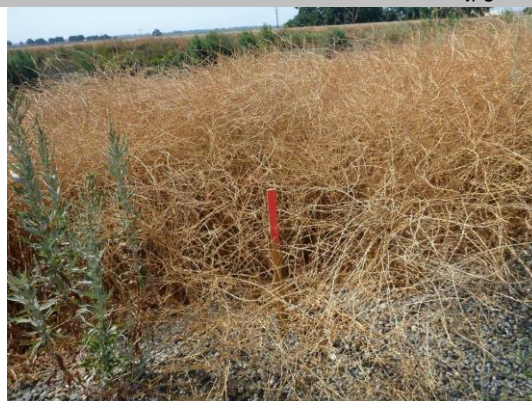
Photo 2 of 3 : LEVAL\_FA\_2018\_547\_4687.jpg

LM Start	2.76	Rating **	A/W	Issue No.	91 (cont)	
LM End	2.77	Issue Type +	Ma	Location *		
Category	Supplemental			GPS Latitude/Longitude		
				Start		End
Item	2017 Storm Damage			37.817400 °		37.817300 °
				-121.352300 °		-121.352500 °
DWR ID	DWR_RD0544_02_f_2017_91

Comment Code						
Inspector Comment						
Levee Evaluation Comments						
Description:Slope protection repairs are needed along the waterside slope due to erosion and riprap displacement from high water. Based upon levee inspections, it was determined the waterside levee slope is eroding, deteriorating, and degrading. The eroded levee sections need to be restored back to design standards to prevent further deterioration and damage.						
Site ID No:547						
Site Designation:LMA-453						
Repair Type: Erosion						
Rating:Area of Concern						
Field Date:8/18/2017						
Notes: levee slopes covered in dense vegetations that hindered visibility.

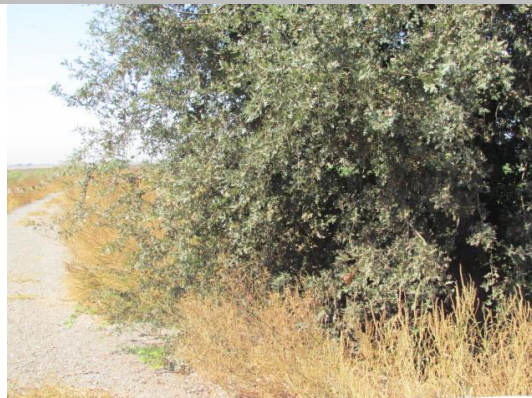
Photo 1 of 1 : FA\_2018\_RD0544\_109\_53\_20180906\_00038.jpg

LM Start	2.80	Rating **	M	Issue No.	53
LM End	2.80	Issue Type +	Ma	Location *	LS
Category	Earthen Levee			GPS Latitude/Longitude	
				Start	End
Item	Trim / Thin Trees			37.817187°	37.817187°
				-121.352964°	-121.352964°
DWR ID	DWR_RD0544_02_f_2014_53				
Comment Code					
T2 : Thin trees to allow visibility of the ground and room to flood fight.					
Inspector Comment

Looking southwest at untrimmed tree on landward slope fall 2015.

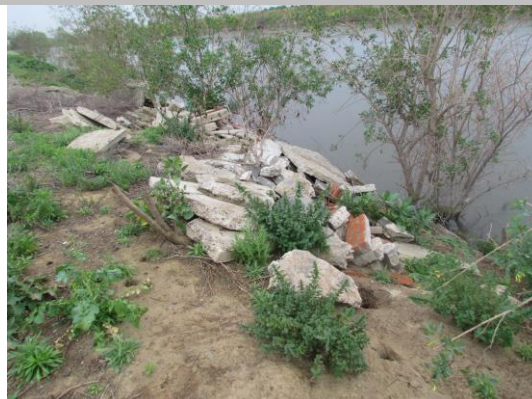
Photo 1 of 1 : FA\_2018\_RD0544\_109\_77\_20180906\_00057.jpg

LM Start	3.10	Rating **	U	Issue No.	77
LM End	3.10	Issue Type +	Ma	Location *	WS
Category	Earthen Levee			GPS Latitude/Longitude	
				Start	End
Item	Erosion / Bank Caving			37.817588°	37.817588°
				-121.358352°	-121.358352°
DWR ID	DWR_RD0544_02_s_2017_77				
Comment Code					
E1 : Note and monitor erosion site.					
Inspector Comment					
Rip rap was placed but does not meet Title 23 standards.

Looking northeast at concrete rubble on waterward slope.

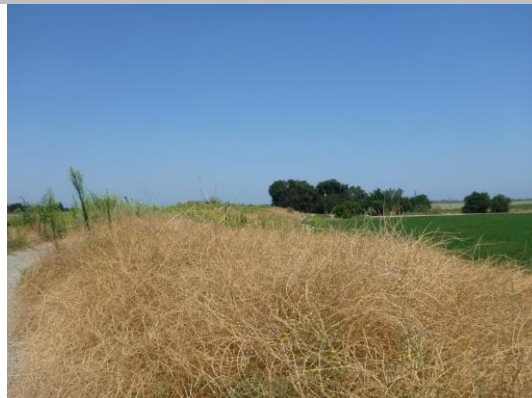
Photo 1 of 3 : LEVAL\_FA\_2018\_546\_4693.jpg

LM Start	3.11	Rating **	A/W	Issue No.	92
LM End	3.12	Issue Type +	Ma	Location *	
Category	Supplemental			GPS Latitude/Longitude	
				Start	End
Item	2017 Storm Damage		37.817700 °	37.817800 °	
			-121.358600 °	-121.358700 °	
DWR ID	DWR_RD0544_02_f_2017_92

Comment Code					
Inspector Comment					
Levee Evaluation Comments					
Description:Slope protection repairs are needed along the waterside slope due to erosion and riprap displacement from high water. Based upon levee inspections, it was determined the waterside levee slope is eroding, deteriorating, and degrading. The eroded levee sections need to be restored back to design standards to prevent further deterioration and damage.					
Site ID No:546					
Site Designation:LMA-452					
Repair Type: Erosion					
Rating:Area of Concern					
Field Date:8/18/2017					
Notes: dense vegetations on both sides of the levee made the slopes inaccessible

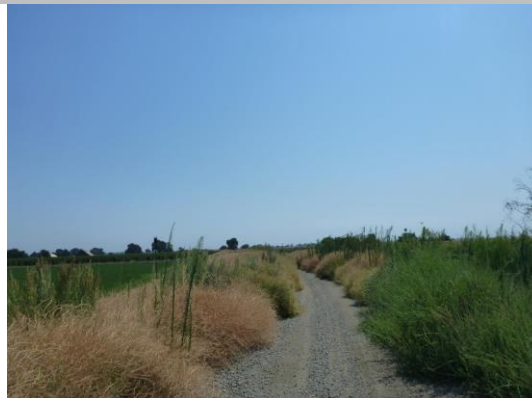
Photo 3 of 3 : LEVAL\_FA\_2018\_546\_4698.jpg

Item	2017 Storm Damage			37.817700°	37.817800°
				-121.358600°	-121.358700°
DWR ID	DWR_RD0544_02_f_2017_92				
Comment Code					
Inspector Comment					
<p>Levee Evaluation Comments</p> <p>Description: Slope protection repairs are needed along the waterside slope due to erosion and riprap displacement from high water. Based upon levee inspections, it was determined the waterside levee slope is eroding, deteriorating, and degrading. The eroded levee sections need to be restored back to design standards to prevent further deterioration and damage.</p> <p>Site ID No: 546</p> <p>Site Designation: LMA-452</p> <p>Repair Type: Erosion</p> <p>Rating: Area of Concern</p> <p>Field Date: 8/18/2017</p> <p>Notes: dense vegetations on both sides of the levee made the slopes inaccessible</p>

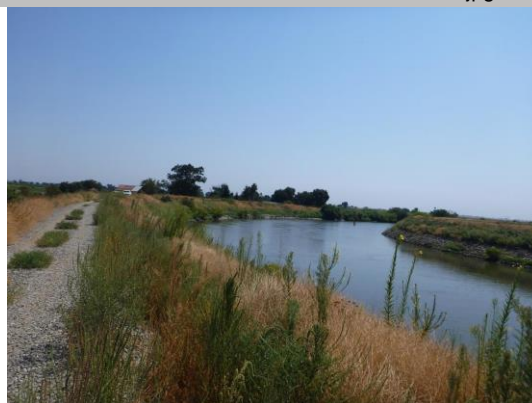
Photo 1 of 3 : LEVAL\_FA\_2018\_545\_4707.jpg

LM Start	3.25	Rating **	A/W	Issue No.	93
LM End	3.34	Issue Type +	Ma	Location *	
Category	Supplemental			GPS Latitude/Longitude	
				Start	End
Item	2017 Storm Damage			37.819300 °	37.819800 °
				-121.360200 °	-121.361600 °
DWR ID	DWR_RD0544_02_f_2017_93				
Comment Code					
Inspector Comment					
Levee Evaluation Comments					
Description:Slope protection repairs are needed along the waterside slope due to erosion and riprap displacement from high water. Based upon levee inspections, it was determined the waterside levee slope is eroding, deteriorating, and degrading. The eroded levee sections need to be restored back to design standards to prevent further deterioration and damage.					
Site ID No:545					
Site Designation:LMA-451					
Repair Type: Erosion					
Rating:Area of Concern					
Field Date:8/18/2017					
Notes:

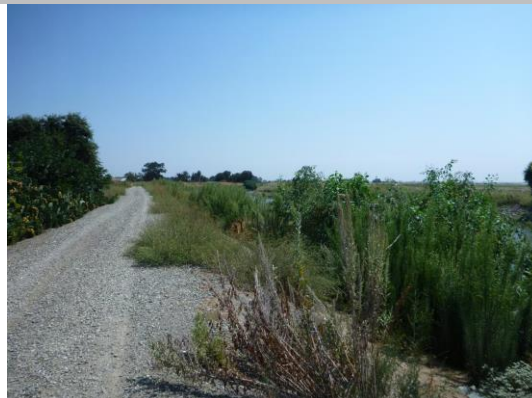
Photo 1 of 3 : LEVAL\_FA\_2018\_544\_4781.jpg

LM Start	<b>3.51</b>	Rating **	A/W	Issue No.	<b>94</b>							
LM End	<b>3.55</b>	Issue Type +	Ma	Location *								
Category	Supplemental		GPS Latitude/Longitude									
			Start	End								
Item	2017 Storm Damage		37.819500 °	37.819400 °								
			-121.364700 °	-121.365400 °								
DWR ID	DWR_RD0544_02_f_2017_94											
Comment Code												
Inspector Comment												
Levee Evaluation Comments Description: Slope protection repairs are needed along the waterside slope due to erosion and riprap displacement from high water. Based upon levee inspections, it was determined the waterside levee slope is eroding, deteriorating, and degrading. The eroded levee sections need to be restored back to design standards to prevent further deterioration and damage. Site ID No: 544 Site Designation: LMA-450 Repair Type: Erosion Rating: Area of Concern Field Date: 8/18/2017 Notes:

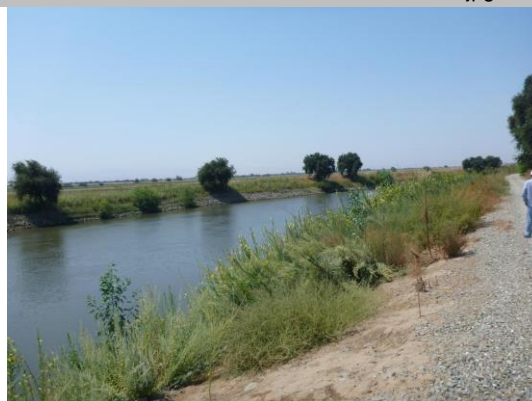
Photo 3 of 3 : LEVAL\_FA\_2018\_544\_4783.jpg

LM Start	3.51	Rating **	A/W	Issue No.	94 (cont)
LM End	3.55	Issue Type +	Ma	Location *	
Category	Supplemental			GPS Latitude/Longitude	
				Start	End
Item	2017 Storm Damage			37.819500 °	37.819400 °
				-121.364700 °	-121.365400 °
DWR ID	DWR_RD0544_02_f _ 2017_94				
Comment Code					
Inspector Comment					
Levee Evaluation Comments					
Description:Slope protection repairs are needed along the waterside slope due to erosion and riprap displacement from high water. Based upon levee inspections, it was determined the waterside levee slope is eroding, deteriorating, and degrading. The eroded levee sections need to be restored back to design standards to prevent further deterioration and damage.					
Site ID No:544					
Site Designation:LMA-450					
Repair Type: Erosion					
Rating:Area of Concern					
Field Date:8/18/2017					
Notes:

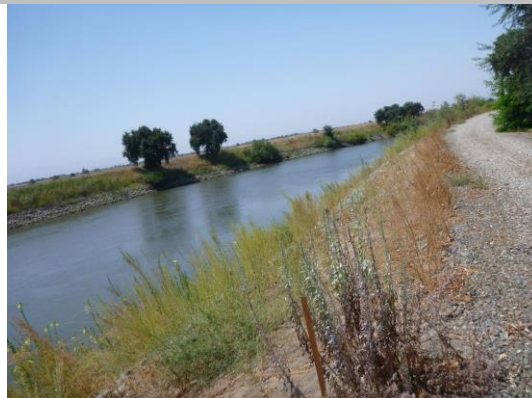
Photo 1 of 3 : LEVAL\_FA\_2018\_543\_4790.jpg

LM Start	3.57	Rating **	A/W	Issue No.	95
LM End	3.58	Issue Type +	Ma	Location *	
Category	Supplemental			GPS Latitude/Longitude	
				Start	End
Item	2017 Storm Damage			37.819400 °	37.819400 °
				-121.365800 °	-121.365900 °
DWR ID	DWR_RD0544_02_f_2017_95				
Comment Code					
Inspector Comment					
Levee Evaluation Comments					
Description:Slope protection repairs are needed along the waterside slope due to erosion and riprap displacement from high water. Based upon levee inspections, it was determined the waterside levee slope is eroding, deteriorating, and degrading. The eroded levee sections need to be restored back to design standards to prevent further deterioration and damage.					
Site ID No:543					
Site Designation:LMA-449					
Repair Type: Erosion					
Rating:Area of Concern					
Field Date:8/18/2017					
Notes:

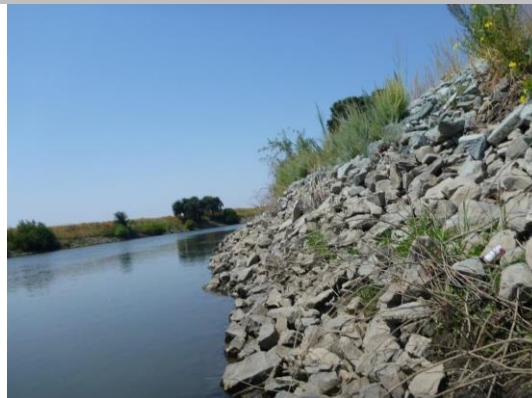
Photo 3 of 3 : LEVAL\_FA\_2018\_543\_4799.jpg

LM Start	3.57	Rating **	A/W	Issue No.	95 (cont)
LM End	3.58	Issue Type +	Ma	Location *	
Category	Supplemental			GPS Latitude/Longitude	
				Start	End
Item	2017 Storm Damage			37.819400 °	37.819400 °
				-121.365800 °	-121.365900 °
DWR ID	DWR_RD0544_02_f _ 2017_95				
Comment Code					
Inspector Comment					
Levee Evaluation Comments					
Description:Slope protection repairs are needed along the waterside slope due to erosion and riprap displacement from high water. Based upon levee inspections, it was determined the waterside levee slope is eroding, deteriorating, and degrading. The eroded levee sections need to be restored back to design standards to prevent further deterioration and damage.					
Site ID No:543					
Site Designation:LMA-449					
Repair Type: Erosion					
Rating:Area of Concern					
Field Date:8/18/2017					
Notes:

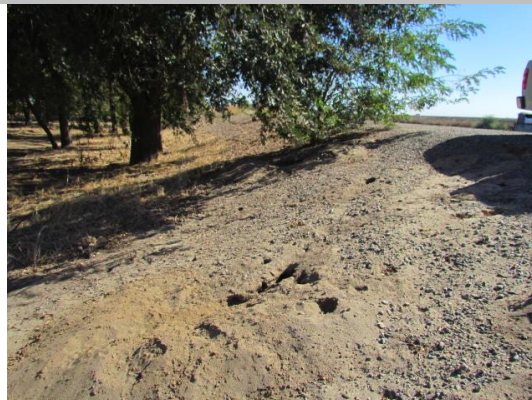
Photo 1 of 2 : FA\_2018\_RD0544\_109\_67\_20180906\_00044.jpg

LM Start	3.58	Rating **	M	Issue No.	67
LM End	3.58	Issue Type +	Ma	Location *	LS
Category	Earthen Levee			GPS Latitude/Longitude	
				Start	End
Item	Animal Control			37.819419 °	37.819419 °
				-121.365854 °	-121.365854 °
DWR ID	DWR_RD0544_02_f_2015_67				
Comment Code					
A3 : No rodents visible, but rodent burrows visible; need to backfill and compact or grout burrows.					
Inspector Comment					
Large rodent holes on landward slope.

Looking northeast at typical view of rodent holes on landward slope.

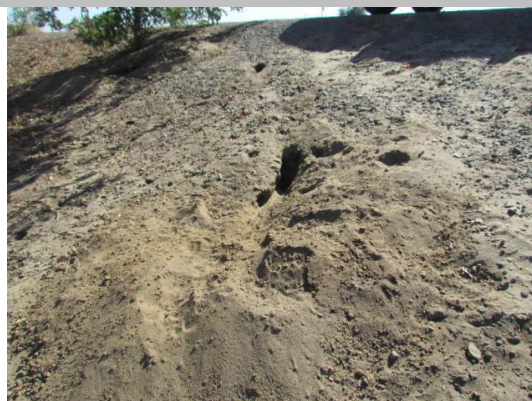
Photo 2 of 2 : FA\_2018\_RD0544\_109\_67\_20180906\_00045.jpg

LM Start	3.58	Rating **	M	Issue No.	67 (cont)	
LM End	3.58	Issue Type +	Ma	Location *	LS	
Category	Earthen Levee			GPS Latitude/Longitude		
				Start		End
Item	Animal Control			37.819419 °		37.819419 °
				-121.365854 °		-121.365854 °
DWR ID	DWR_RD0544_02_f_2015_67					
Comment Code						
A3 : No rodents visible, but rodent burrows visible; need to backfill and compact or grout burrows.						
Inspector Comment						
Large rodent holes on landward slope.

Looking north at typical view of rodent holes on landward slope.
